HYDROLOGIC AND HYDRAULIC ASSESSMENT

SHADOW LAKE DAM

VT DEC ID NO. 81.02

January 30, 2023

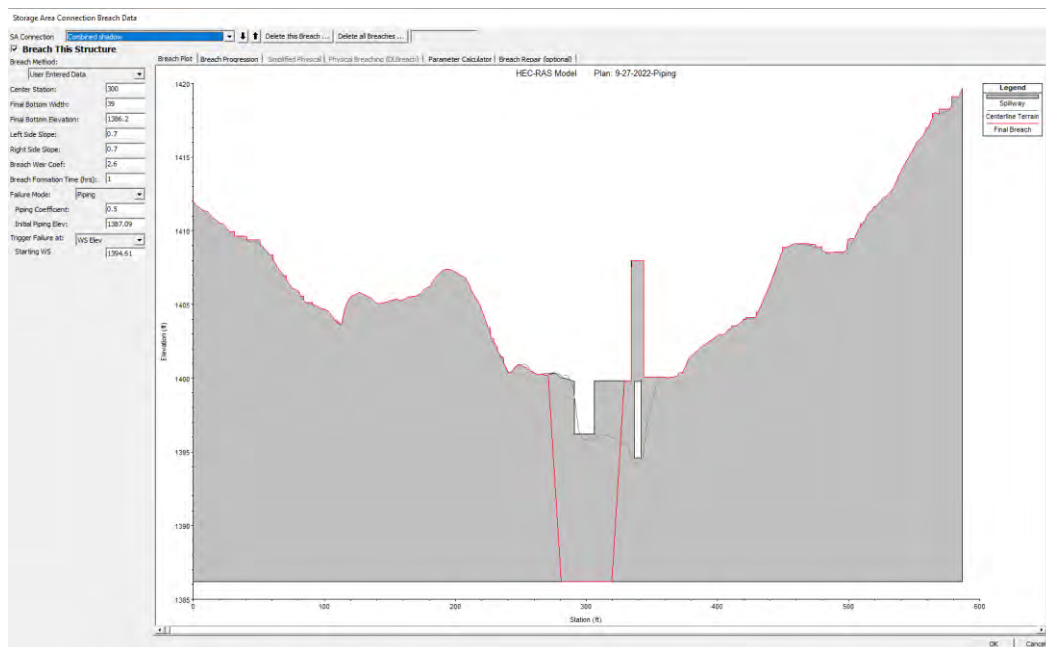
The Sunny Day Piping Failure calculated a breach bottom width of 15 feet with 0.7H: 1V side slopes, which results in a 31.2 ft wide top width.

FERC recommends an average breach width of $\text{Height of Dam} < \text{Avg. B Breach Width} < 5 \times \text{Height of Dam}$ for Earthen Structures that would correspond to $13 \text{ ft} < X < 65 \text{ ft}$. For masonry gravity structures FERC recommends an Avg. Breach Width of $< 0.5 \times \text{Dam Crest Length}$ which would correspond to $X < 65 \text{ ft}$. Based on these recommended ranges it appears the upper limit of the breach average width is 65 ft while the lower limit is 13 ft. An average of these two values yields 39 ft which is larger than the 31.2 ft top width currently being modeled.

The Sunny Day Piping Failure dimensions are shown on the figure below.

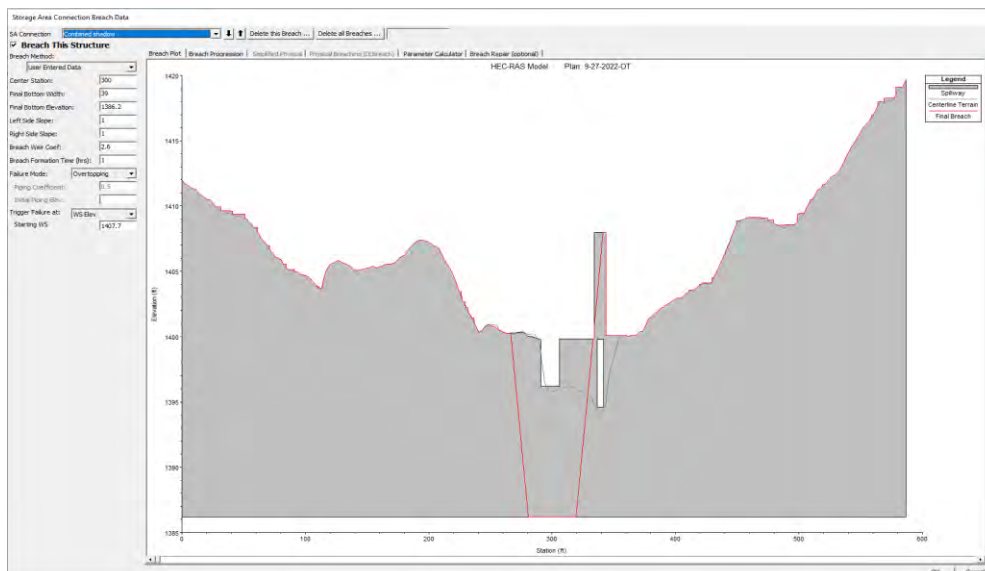
The Froehlich 2008 breach equations compute an average breach width of 205 ft for the Storm Day PMF dam failure with the reservoir elevation at the peak of 1407.8. The Storm Day Overtopping Failure calculated a breach bottom width of 15 feet with 1H: 1V side slopes that results in a 41 ft wide top width.

FERC recommends an average breach width of $\text{Height of Dam} < \text{Avg. B Breach Width} < 5 \times \text{Height of Dam}$ for Earthen Structures which would correspond to $13 \text{ ft} < X < 65 \text{ ft}$. For masonry gravity structures FERC recommends an Avg. Breach Width of $< 0.5 \times \text{Dam Crest Length}$ that would correspond to $X < 65 \text{ ft}$. Based on these recommended ranges it appears the upper limit of the breach average width is 65 ft while the lower limit is 13 ft. An average of these two values yields 39 ft, which is similar to the 41 ft top width utilized in the model. The Storm Day Overtopping Failure dimensions are shown on the figure below.

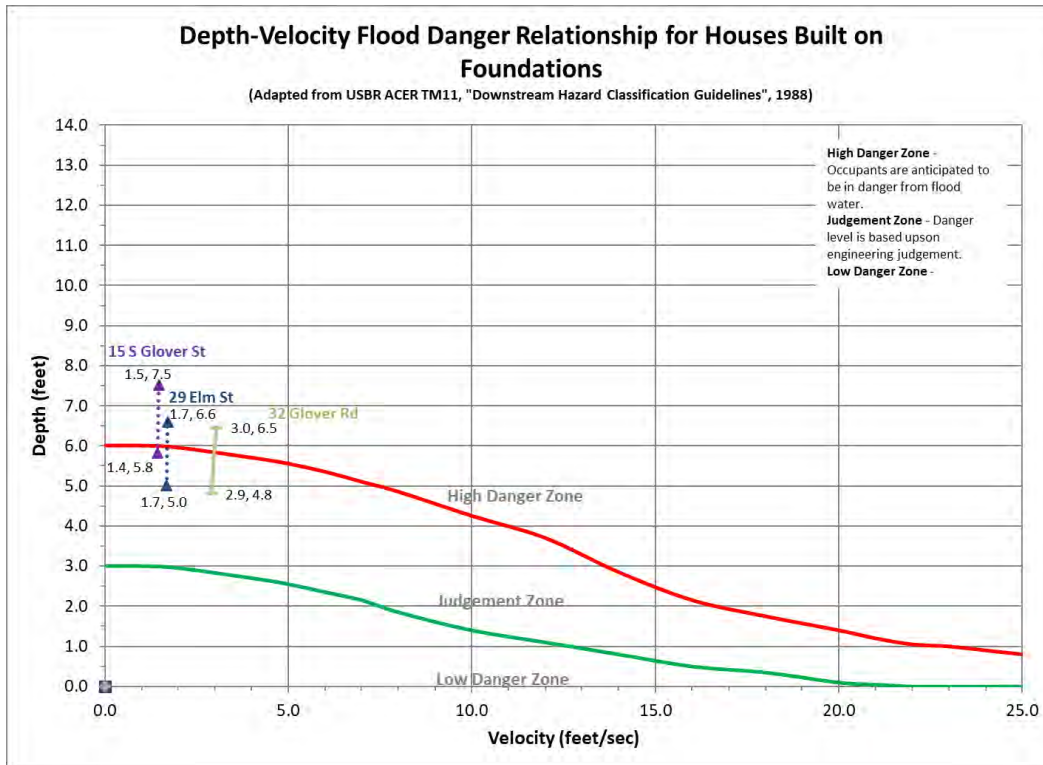
1. During the 1000-yr dam failure vs 1000-yr no dam failure comparison, three (3) structures were identified that transition from being in the JUDGEMENT zone (Yellow) to the HIGH danger zone (Red) on the USBR ACER- 11 chart. These structures, summarized in table 7 below were already located within the upper half of the JUDGEMENT zone which generally indicates that the loss of life is likely. In addition, the increase in flooding depth at these structures’ ranges from 1.58 to 1.68 ft which is less than the applied 2-foot threshold for structures with foundations. Furthermore, the incremental increase in flood velocity was only 10% to 20%.

*Listed depth values shown on the chart are taking into account first floor elevation.

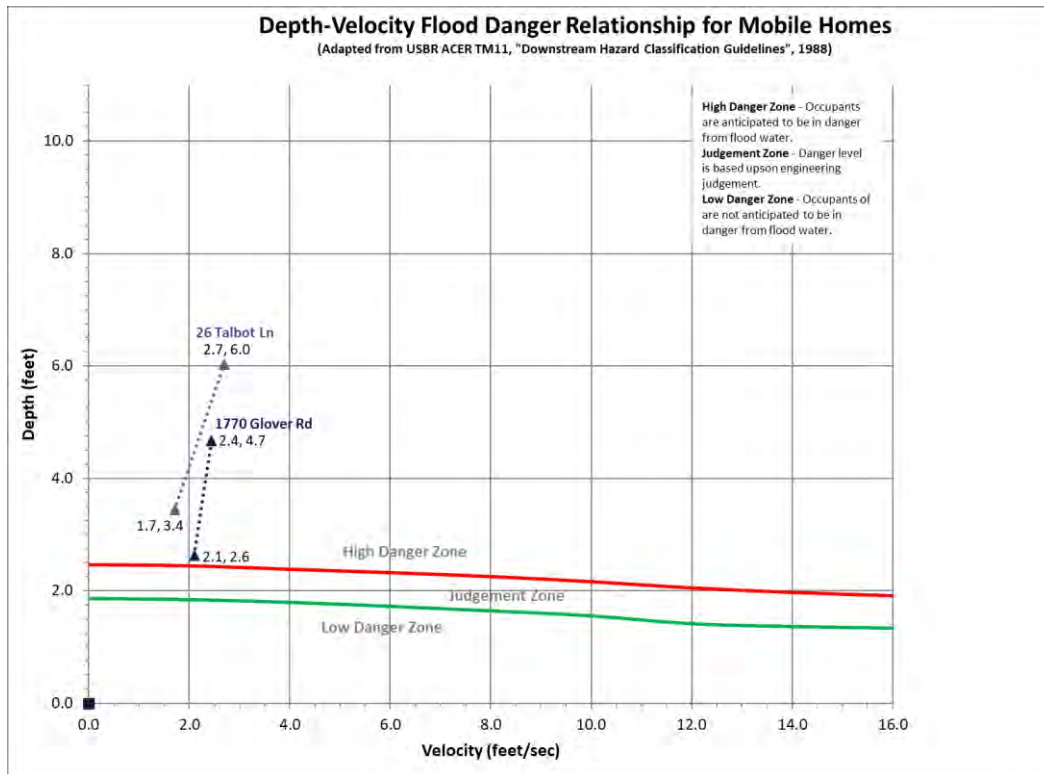
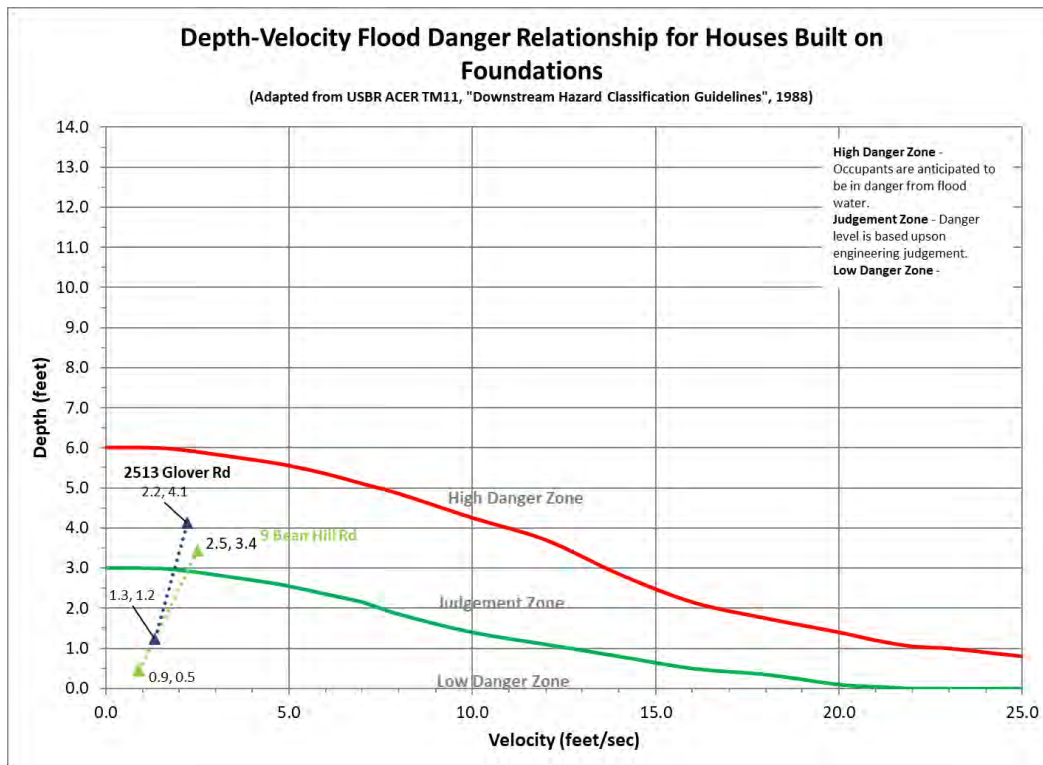
2. During the 1000-yr dam failure vs 1000-yr no dam failure comparison, four (4) structures were identified that experience incremental flooding rises greater than 2 feet (maximum of 2.98 feet). Of these four structures, two (2) structures plotted in the HIGH danger zone (Red) with and without dam failure. The remaining two (2) structures transition from the LOW danger zone (Green) to the Judgment Zone (Yellow), but both structures end up plotting in the middle to lower half of the JUDGMENT zone, and therefore loss of life was not considered probable. See table 8.

*Listed depth values show on the chart are taking into account first floor elevation.

** The two connected green dots are 9 Bean Hill road. This is the structure which has a first floor elevation 3 ft plus higher than native grade (by counting steps when looking at google street view). By accounting for a 3 ft above native grade the dam failure point will no longer plot in the upper half of the judgement zone.

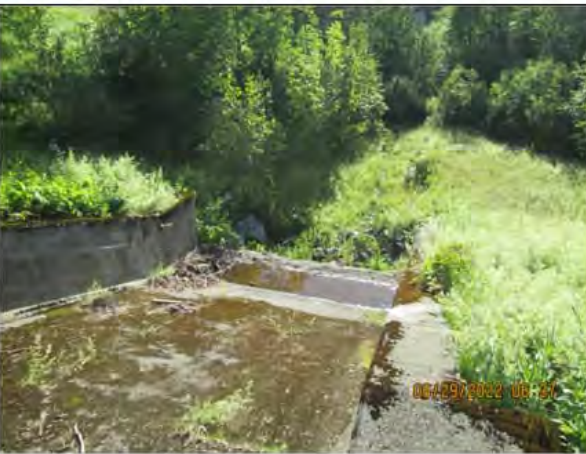
Photo No.: 2	Date: 6-29-2022

Photo Orientation: East		
Description: Shadow Lake Dam auxiliary spillway (chute)

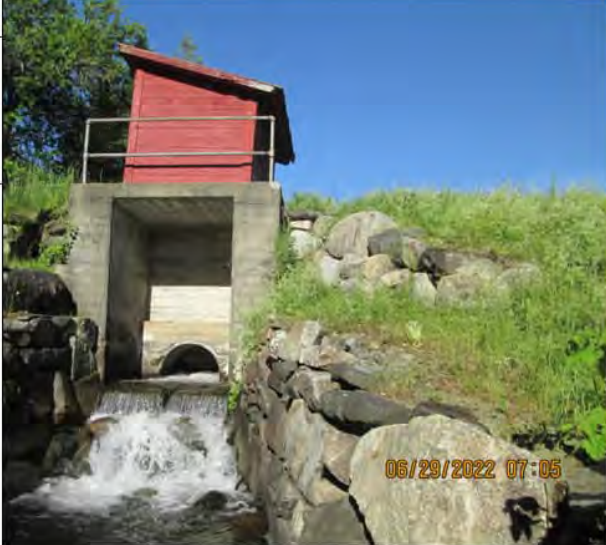
Photo No.: 5	Date: 6-29-2022

Photo Orientation: North West		
Description: Shadow Lake Dam primary spillway gatehouse outlet.
